## Precious Cargo Below: Replacing the Roof on a Veterans Hospital

## Hospital Roof Restored

Install a roof restoration system over the emergency room and MRI wing of a Topeka, Kan., veterans hospital

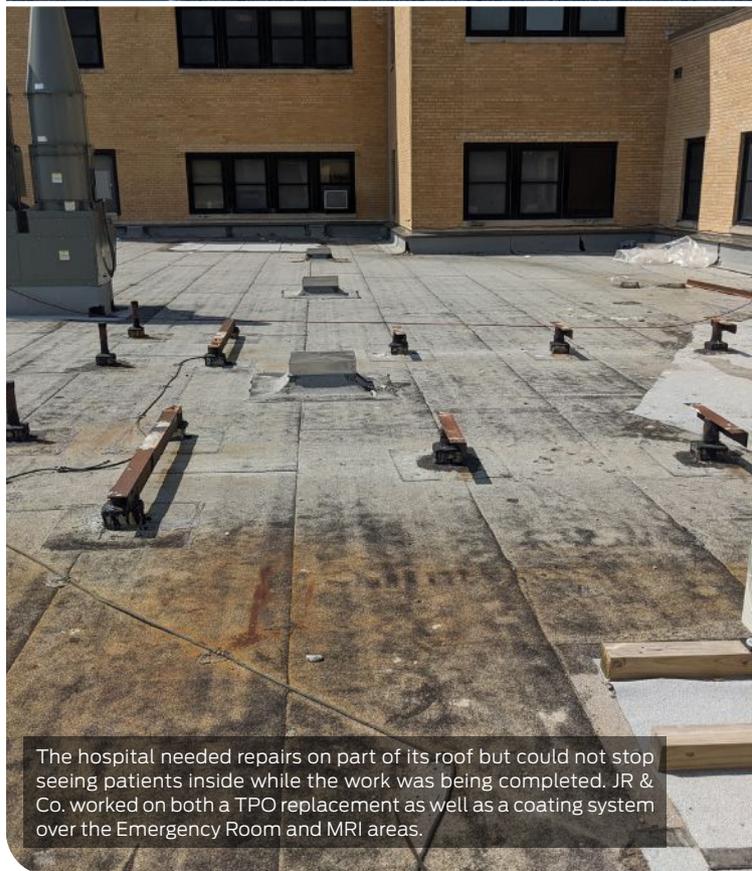
The hospital needed repairs on part of its roof but could not stop seeing patients inside while the work was being completed. JR & Co. worked on both a TPO replacement as well as a coating system over the Emergency Room and MRI areas.

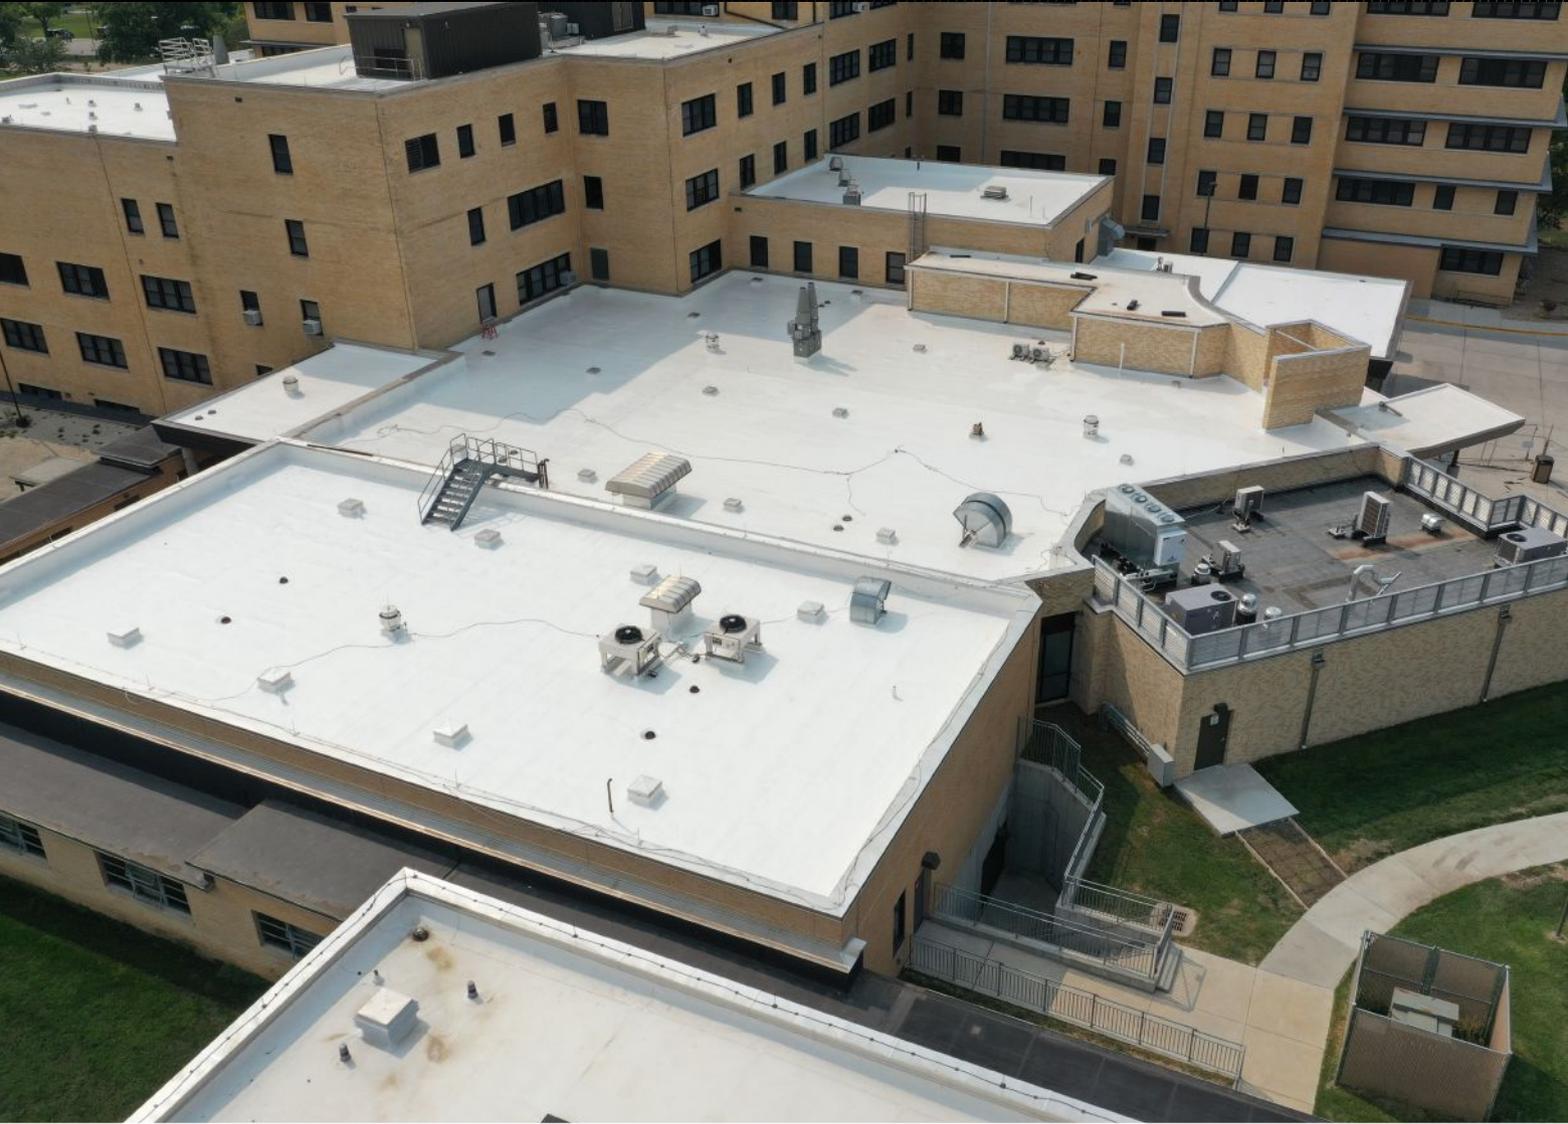
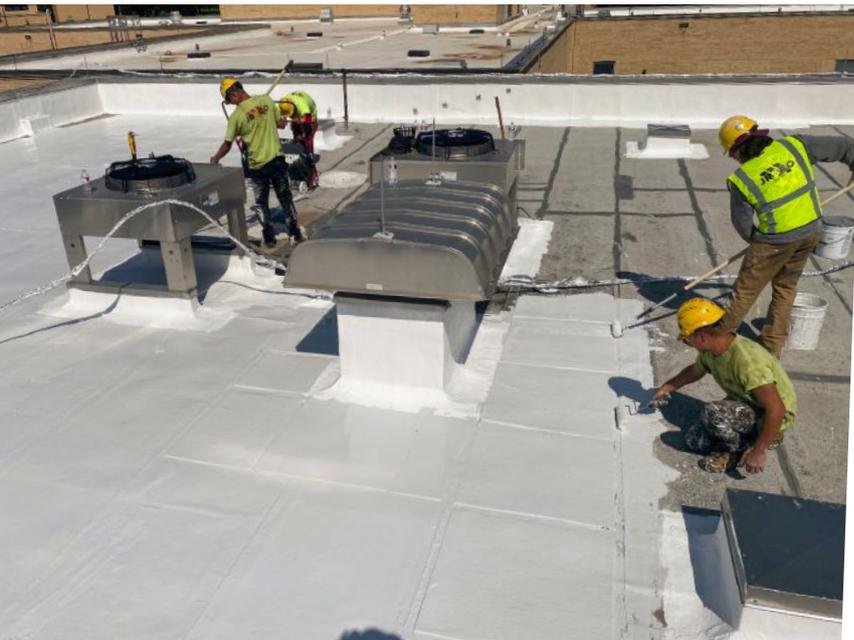
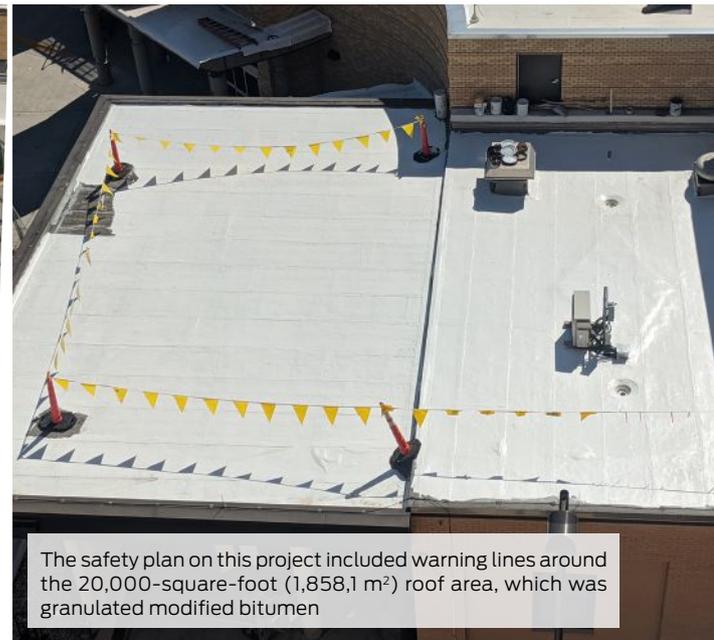
The safety plan on this project included warning lines around the 20,000-square-foot (1,858,1 m<sup>2</sup>) roof area, which was granulated modified bitumen

- » Set up warning lines and fall arrest systems using choker straps fixed to roof curbs and attached to Guardian cable boxes
- » Wore DBI-Sala safety harnesses, hard hats, cut-resistant gloves, safety glasses, and high-vis shirts or vests
- » Stationed a safety monitor on smaller roof areas; otherwise, kept all personnel within the safety lines or tied off using a fall arrest system

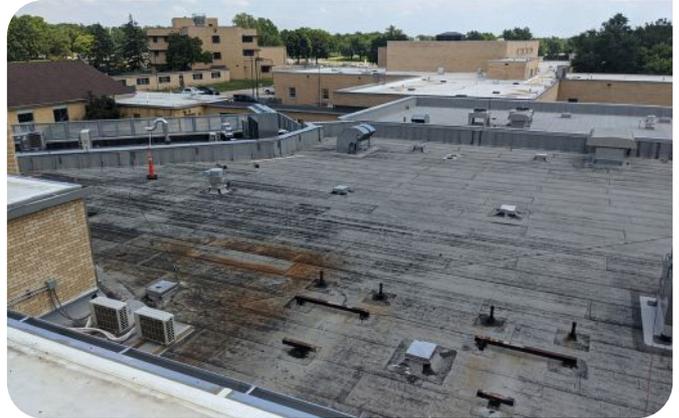
After using 4,000 psi (27.6 MPa) Mi-T-M rotary walk-behind pressure washers, blemishes were repaired and ERSYSTEMS’ H.E.R. polyurethane sealant was applied to field and lap seams and other protrusions.

To start the project, Schlossenberg’s six-man crew used rotary walk-behind pressure washers from Mi-T-M to pressure wash and clean the roof. They were 28-inch (71.1 cm) pressure washers operating at 4,000 psi (27.6 MPa).

“The roofs were washed and rinsed clean,” Schlossenberg said. “From there, we started to repair any blemishes in the existing granulated modified roof system, such as blisters, loose seams, punctures, ball and curve flashings, and roof drains. We had to remove and reset the lightning rod protection system that was installed across the roof substrate. There were approximately 12 existing roof penetrations that had to be removed and replaced with in-kind materials. There were five to six different roof facets, or roof areas, that we completed,” Schlossenberg said, but they did it all within three weeks.

Next, the crew applied ERSystems’ H.E.R. moisture-cure polyurethane sealant to all field seams, lap seams, ball seams, curve flashings, pipe flashings, and other roof protrusions. Then they installed six-ply drain details to all 14 interior drains using a combination of the H.E.R. sealant and ERSystems’ Polyurethane 300 Aromatic Base Coat. The crew also used the H.E.R. sealant to encapsulate the edges of the existing walk track, making it seamless with the rest of the roof system.

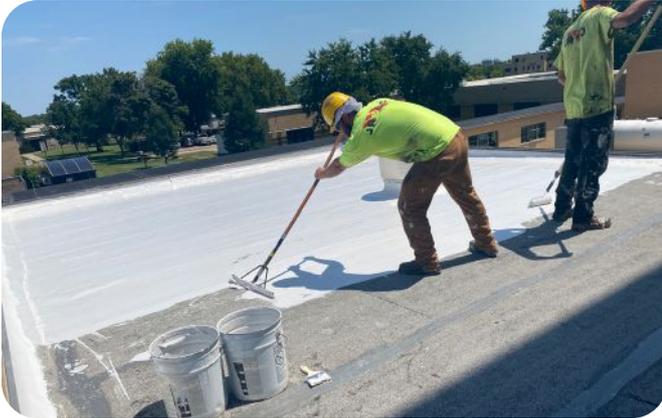
A urethane basecoat was applied to all areas at 2 gallons per square foot (7.6 L/0.1 m<sup>2</sup>). An intermediate coat was put down at the same thickness, finished with a topcoat at 1.5 gallons (4.7 L) per square foot.

The crew put down three total coats. “Using a Super Spreader, we backrolled and applied ERSystems’ urethane basecoat at 2 gallons per square foot [7.6 L/0.1 m<sup>2</sup>],” said Schlossenberg. “We applied the basecoat to the entire substrate, including walls, curves, and flashings.”

An intermediate coat was put down using the same product at the same thickness, and it was finished with a topcoat for

a third and final pass. “We installed ERSystems’ aliphatic urethane finish coat at 1.25 gallons per square foot [4.7 L/0.1 m<sup>2</sup>] to the entire substrate, to include walls, curves, and flashings,” continued Schlossenberg.

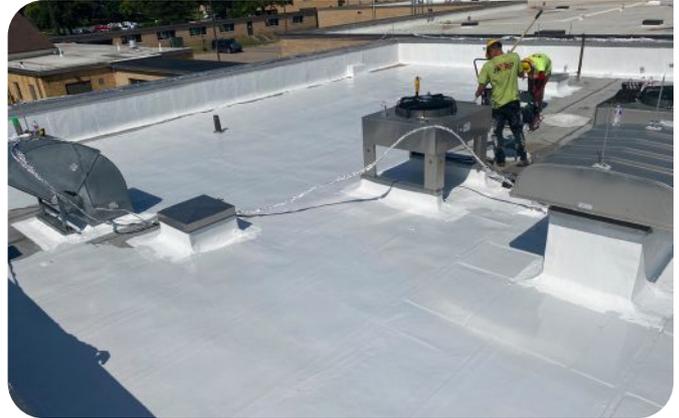
The hospital was able to serve its veteran patients throughout the restoration. And the coatings crew stayed safe throughout too, wearing, hard hats, hi-vis shirts or vests, and fall protection when necessary.

using choker straps fixed to roof curbs and attached to Guardian cable boxes, fire extinguishers, DBI-Sala safety harnesses, hard hats, cut-resistant gloves, safety glasses, and hi-vis shirts or vests,” stated Schlossenberg. “A safety monitor was used on smaller roof areas less than 50 feet [15.2 m] wide. Otherwise, all personnel were within the safety lines or tied off using a fall arrest system.”
