# Good As New & Changes Hue!

## UV-Sensitive Coating System Gives New Life to an Old Roof

By Michele Ostrove

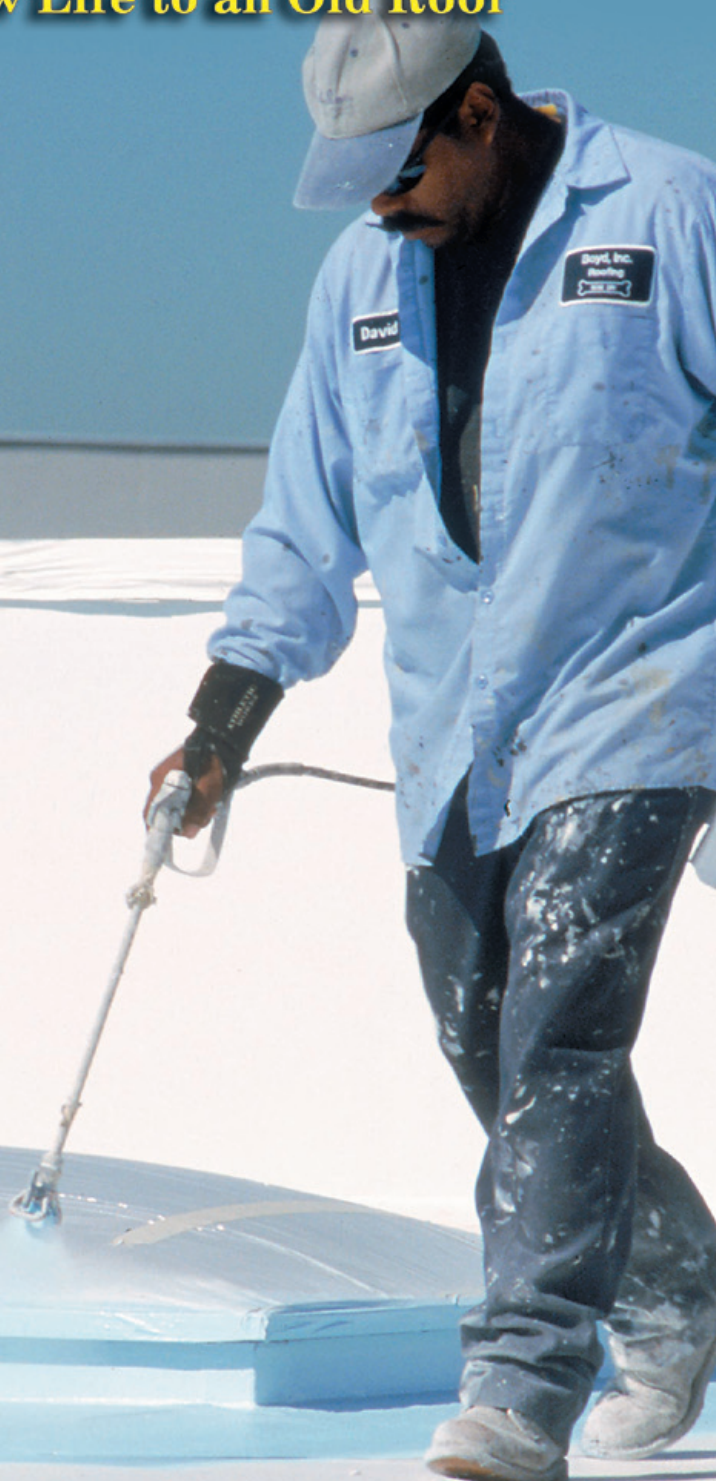
Originally covered with black EPDM and then painted white 16 years ago, the 10-acre roof of this Pier 1 Imports warehouse in Fort Worth, Texas is coated with the UV-sensitive Eraguard 1000, a low-VOC acrylic that goes on blue and turns white within a few hours of sun exposure. The new coating reduced the average temperature of the roof by 40 to 60 degrees.

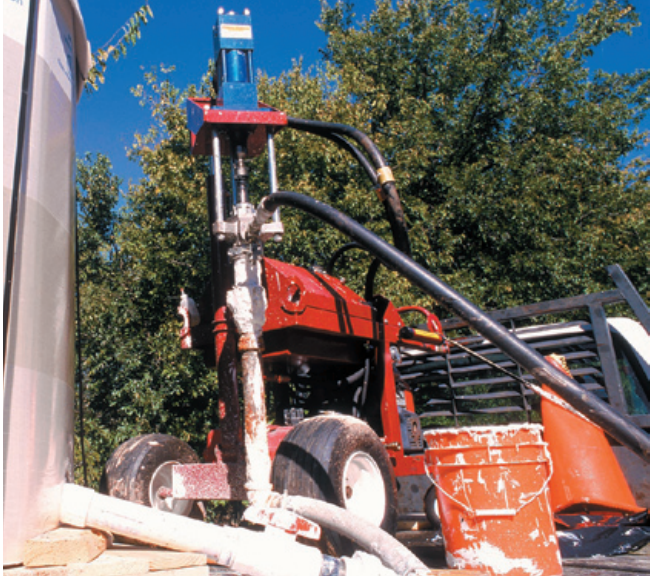
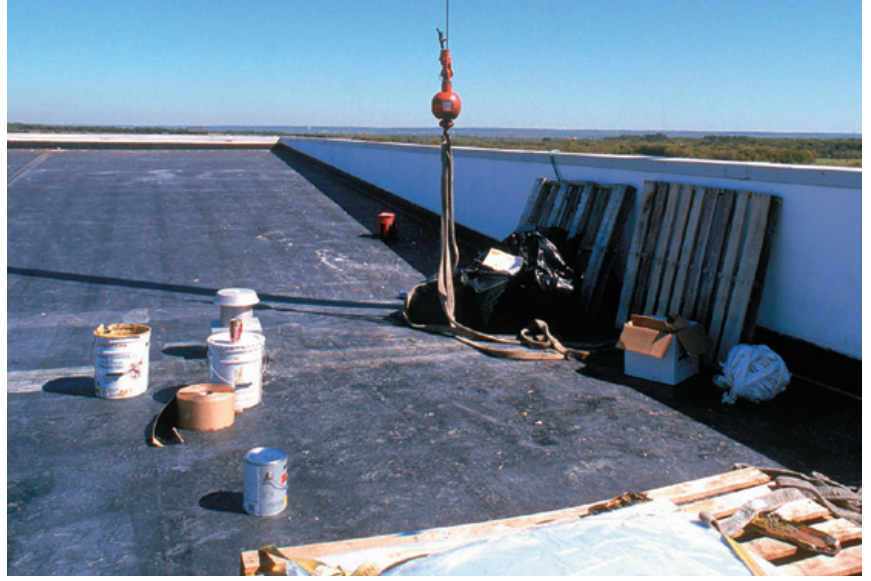
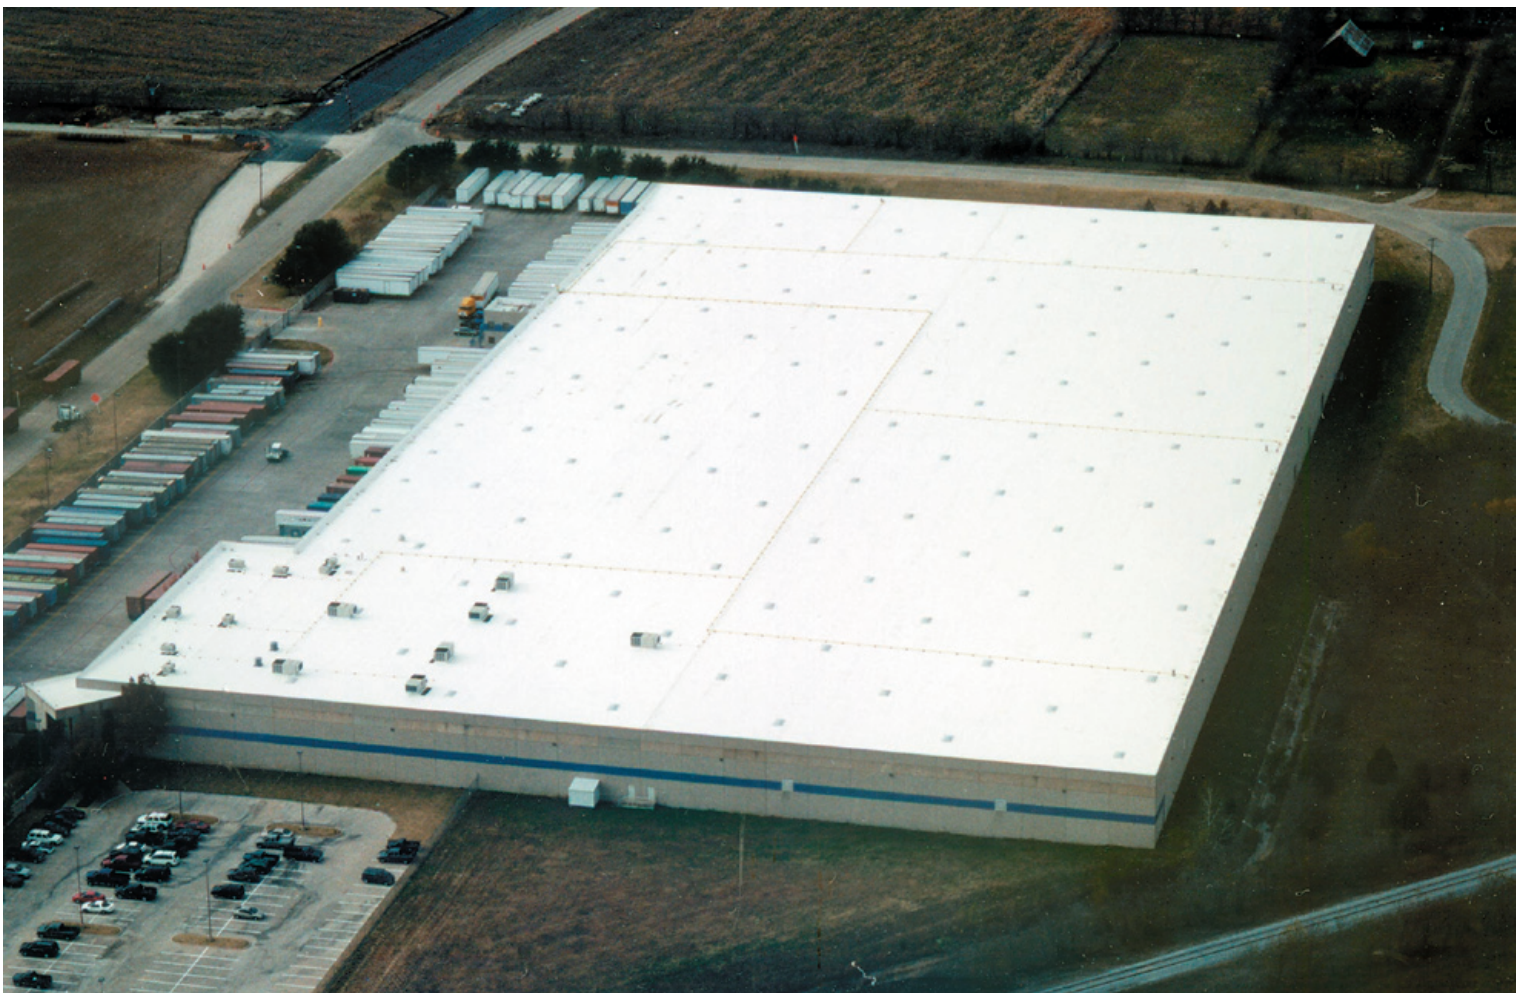
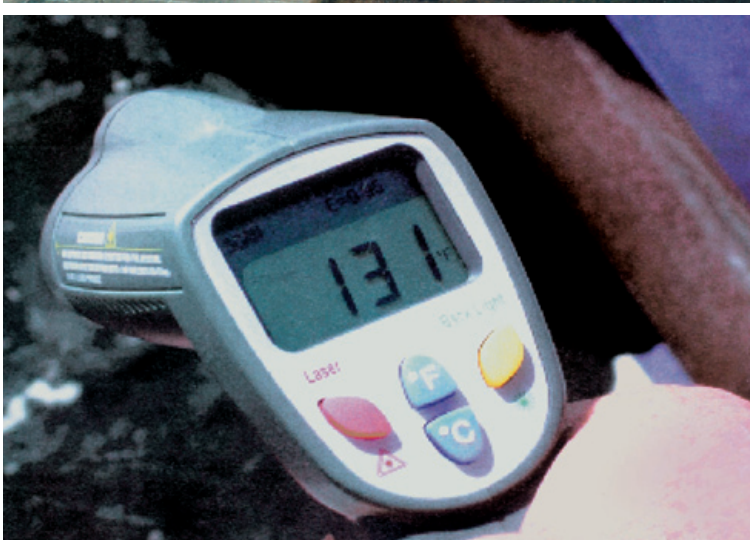
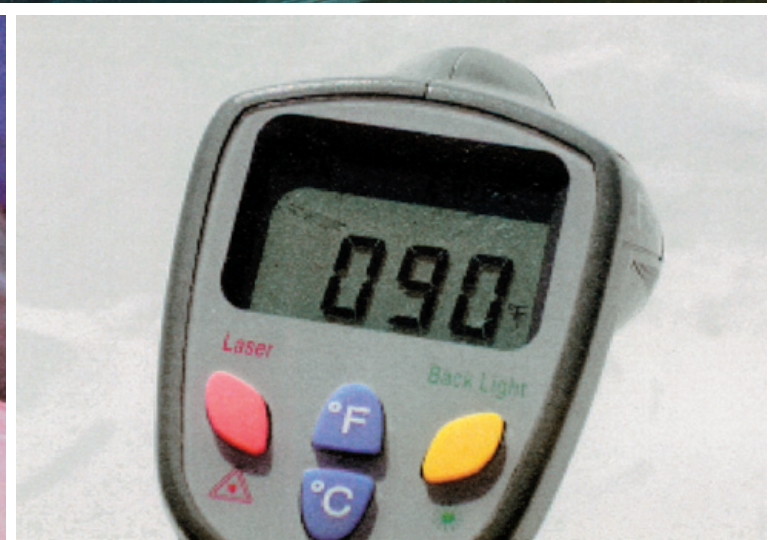
(Facing page, clockwise from top left), the Eraguard 1000 coating was applied with airless spray equipment pumped by two hydraulic machines stationed on the ground. The old EPDM roof was adhered to rigid foam insulation that was mechanically attached to a 22-gauge-steel deck, adding to the difficulty of surface prep. Seen from above, the newly coated 10-acre warehouse roof will yield huge energy savings for Pier 1. An October 2003 temperature comparison between the old EPDM roof and newly coated roof showed a significant temperature decrease.

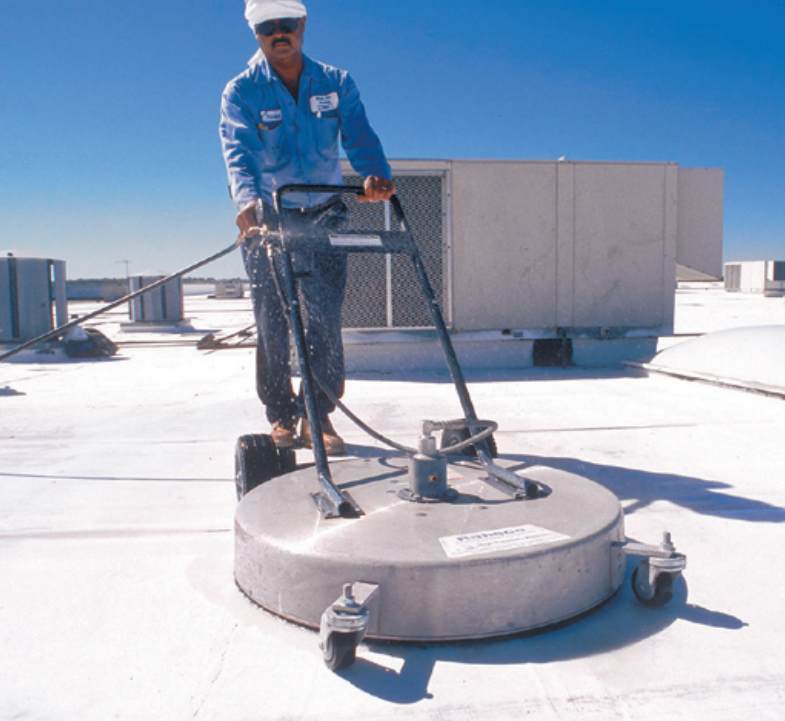
Crews spent an inordinate amount of time on surface prep of the warehouse roof. The first step was power washing (above), using a Rahsco standard power washer and 30-inch surface cleaner power washer, which operates like a push-type lawnmower, but gets the job done thoroughly.

“We spent an inordinate amount of time preparing the roof, first by power washing,” says Boyd. “Then the crews got on their hands and knees, gently scraping the loose coating to make sure we got it all off.” They used a Rahsco 4013 4,000 PSI standard power washer and a Rahsco cc8330 30-inch surface cleaner power washer,

which, he says, “was a godsend. It looks like a typical push-type lawnmower, with a rotating power washer underneath. It really cleaned the roof well.”

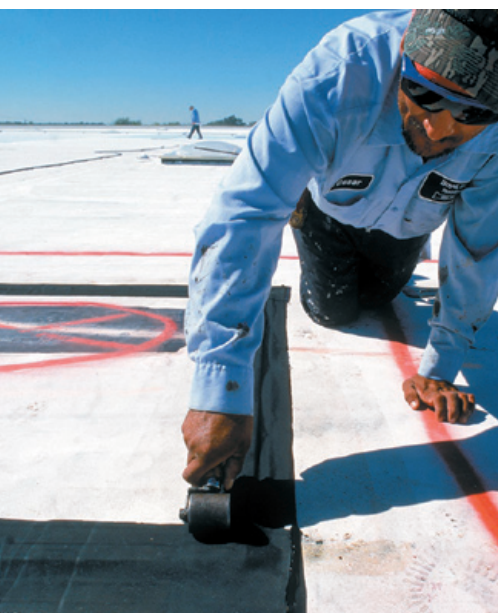
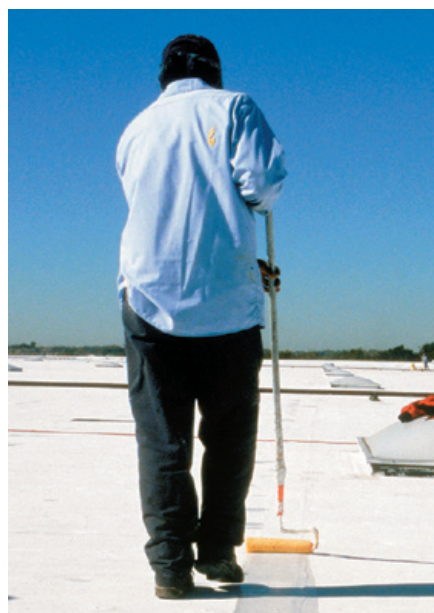
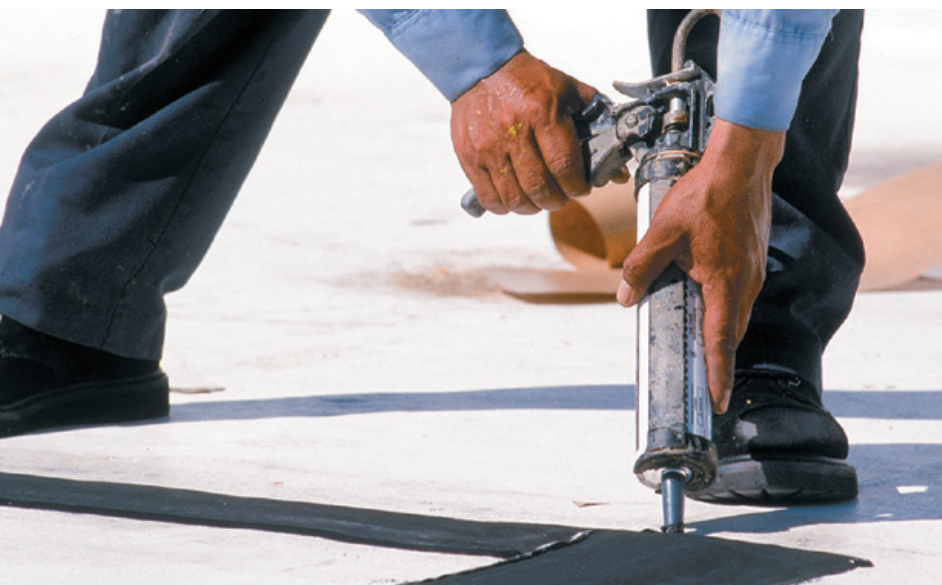
The preparation of the new roof required the repair of more than 200 old patches (*top*), followed by a coating of a single component, moisture-cured polyurethane primer. The primer helped to enhance adhesion of the fabric-backed butyl tape that was applied along the seams. In all, Boyd crews used 35,000 linear feet, or seven miles, of seam tape.

Replacing damaged sections of the old 45-mil EPDM with 10,000 square feet of new 60-mil EPDM required several steps. First, crews mechanically attached the new insulation and then glued recover board with a low-rise foaming adhesive using an adhesive gun (*above*). The 444,400 square-foot roof contained seams around each of the 20-foot-wide sheets of EPDM, as well as around every skylight and other penetration of the rubber (*top left*). All had to be primed and taped before coating could be applied (*top right*).

After prepping the roof and repairing more than 200 old patches, they laid down a coating of ERSystems’ Primer One, a single component, moisture-cured polyurethane. The primer was used to enhance adhesion of ERSystems’ fabric-backed butyl tape, which would be applied along the seams of the EPDM. “We used 35,000 linear feet of seam tape. That’s about seven miles,” notes Boyd. Not only were there seams all around each of the 20-foot-wide sheets of EPDM — every skylight and other penetration had required cuts in the rubber that also had to be primed and taped.

Getting all these repair materials — including 10,000 square feet of 60-mil EPDM that replaced damaged sections of the old 45-mil material — onto the roof was an ordeal in itself, requiring a Manitex 61-foot boom truck with an additional 41-foot jib. According to Boyd, crews mechanically attached the new insulation and then glued Georgia-Pacific’s DensDeck roof guard/recover board to the new insulation with ERSystems’ OlyBond 500 low-rise foaming adhesive, using its PaceCart adhesive gun. The materials were stored at the site in three 10-by-25-foot Mobile Mini storage containers, and moved around the site with a 34-foot Skytrack all-terrain fork lift.

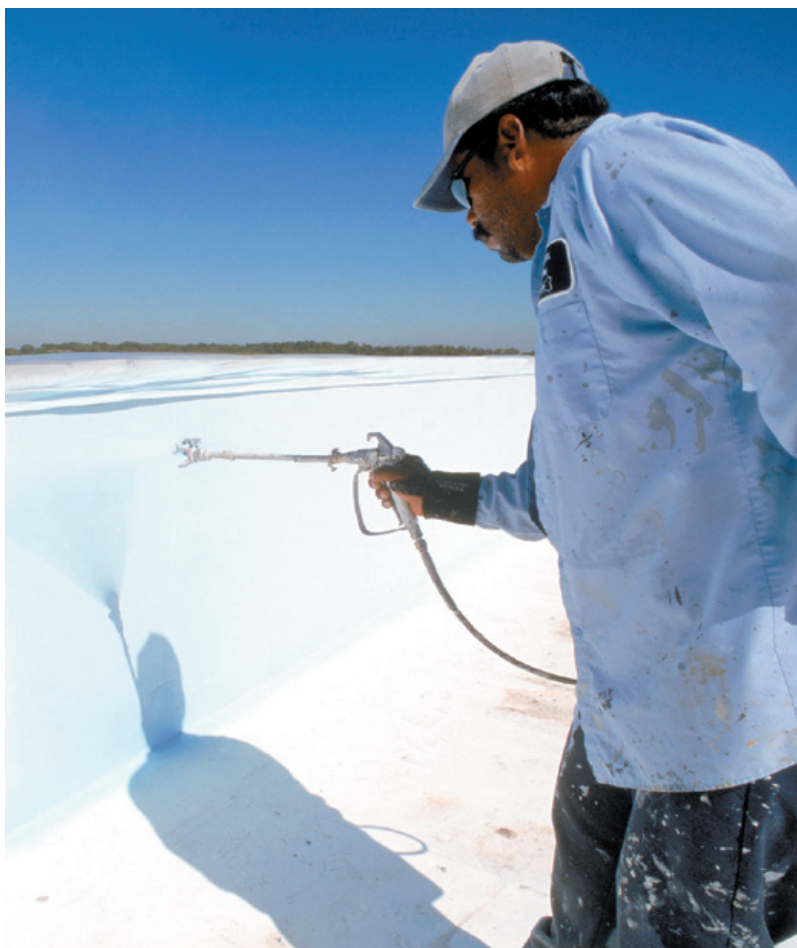
ERSystems’ roof restoration program allowed Pier 1 Imports to repair its existing roof without completely replacing it, using two different, moisture-retardant acrylic coatings to reinforce weaknesses in the EPDM membrane. The redo extended the life of the roof for another 15 years.
